Manhole Inspection Summary

Manhole # S13AA1025MH

Location Address: **3700 OVERVIEW RD**

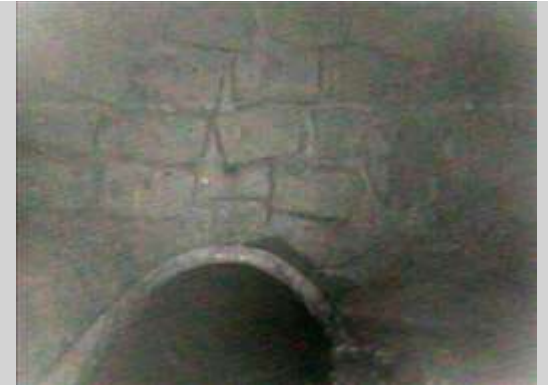
12 O'Clock Outflow

8 in. Circular Gravity Sewer
Pipe Out @ 12 O'Clock

Invert Depth: **11.90** (ft.) Flow Characteristics: **Fast**

Infiltration: **None** Pipe Seal Cond: **Sound**

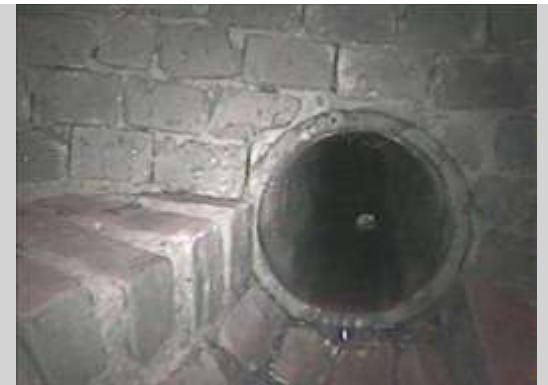
3 O'Clock Inflow

8 in. Circular Gravity Sewer
Pipe In @ 3 O'Clock

Invert Depth: **11.05** (ft.) Flow Characteristics: **Fast**

Infiltration: **None** Pipe Seal Cond: **Sound**

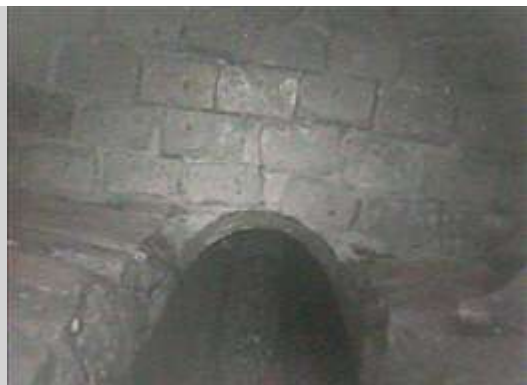
6 O'Clock Inflow

8 in. Circular Gravity Sewer

Pipe In @ 6 O'Clock

Invert Depth: **11.75** (ft.) Flow Characteristics: **Fast**

Infiltration: **None** Pipe Seal Cond: **Sound**
